INDOOR AIR QUALITY REASSESSMENT

**Mt. Greylock Regional High School
Mount Greylock Regional School District
1781 Cold Spring Road
Williamstown, Massachusetts**

Prepared by:
Massachusetts Department of Public Health
Bureau of Environmental Health Assessment
July 2003

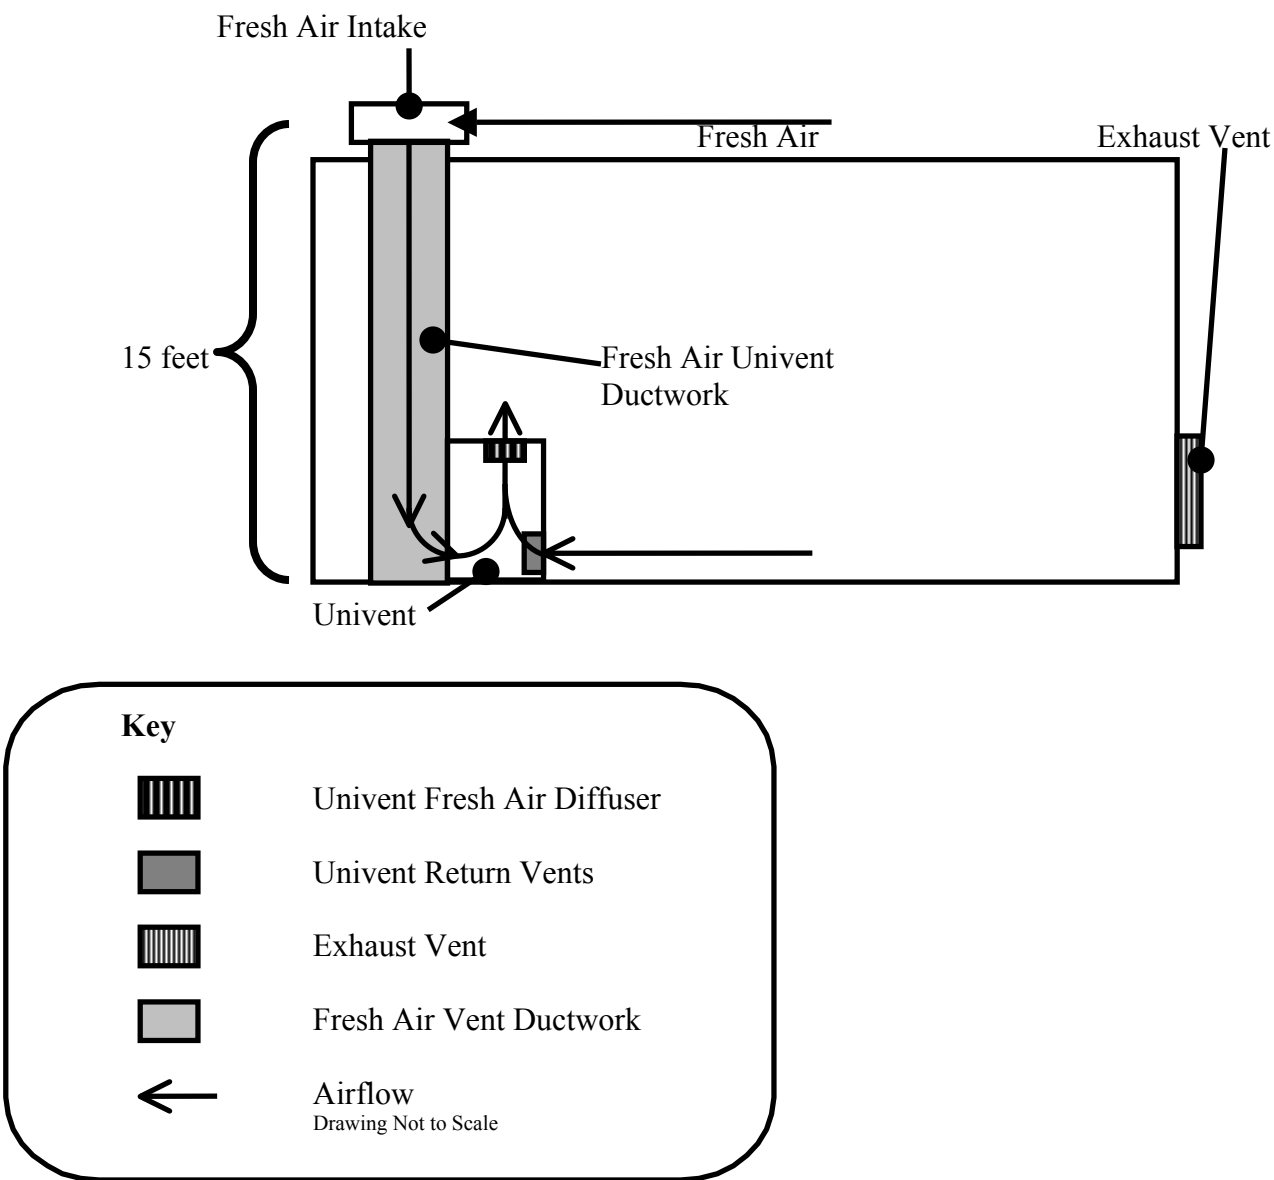
Figure 2

Fresh air in interior classrooms that do not have windows (e.g., 56, 59, 60) is provided by rooftop fresh air intakes that are connected to univents by ductwork (see Figure 2). These vents are designed to use the univent fan to draw fresh air into these intakes and distribute air into ductwork connected to the classroom univent. In general, univents are designed to draw air from fresh air supply vents that are at the same level as and within two feet of the rear of its cabinet. As an example, all classrooms in the MGRHS with windows (perimeter classrooms) are configured in this manner. Interior room supply ductwork is approximately 15 feet in length. In addition, fresh air must make three 90° turns through ductwork prior to reaching the univent

fans. As a general rule, each 90° bend in ducting will reduce the draw of air by 50 percent. In this case, the fresh air must make roughly 270° in turns. Assuming that the velocity of the draw of air at the univent fan equals 100 percent, the draw of air at the base of the vent is reduced to roughly 12.5 percent of the draw because of the three 90° bends in the ductwork.

Configuration of Airflow in Interior Classrooms of Mount Greylock Regional High School

2. Examine the feasibility of introducing more fresh air into air shafts of interior room univents to increase distribution of fresh air.
3. Replace water stained ceiling tiles adhered to ceilings. Examine the area above these tiles for continuing water leaks and repair. Remove mold contaminated materials in a manner consistent with recommendations found in "Mold Remediation in Schools and Commercial Buildings" published by the US Environmental Protection Agency, Office of Air and Radiation, Indoor Environments Division, Washington, DC. EPA 402-K-01-001. March 2001. Copies of this document can be downloaded from the US EPA website at: http://www.epa.gov/iaq/molds/mold_remediation.html.

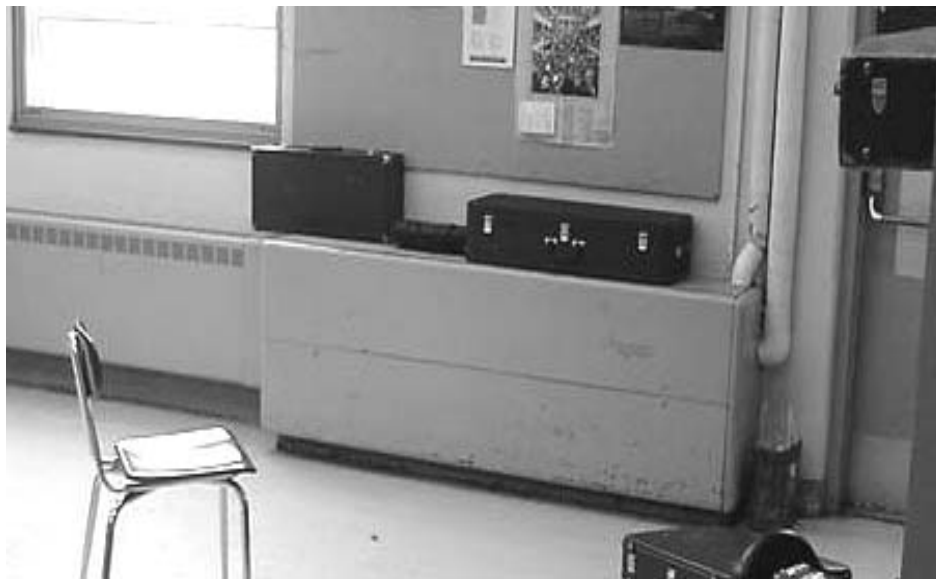
Picture 1

Fresh air in most classrooms is supplied by a unit ventilator (univent) system (see Picture 1). Univents draw air from outdoors through a fresh air intake located on the exterior walls of a building and return air through an air intake located at the base of each unit. The mixture of fresh and return air is drawn through a filter and a heating coil, and is then expelled from the

Univent

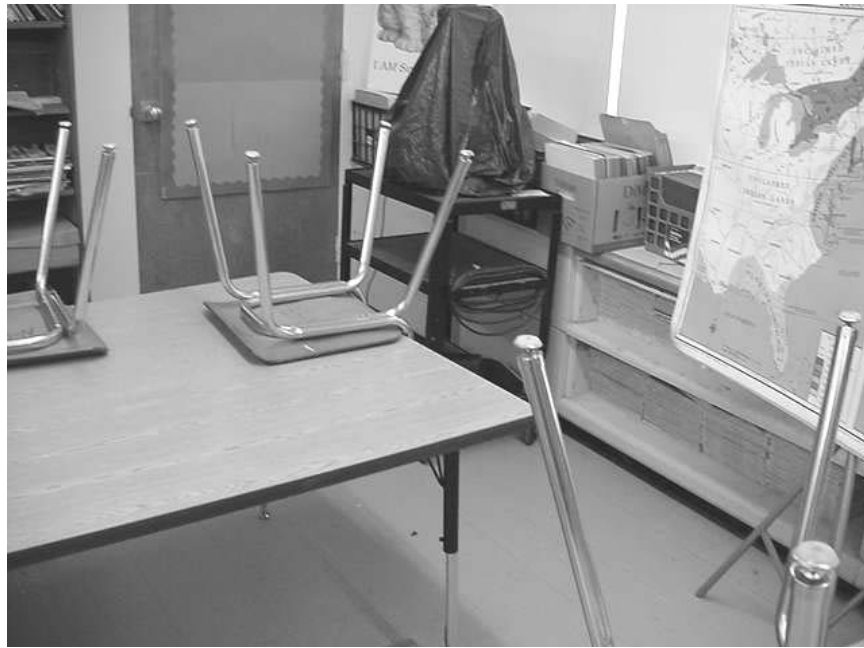
Picture 2

univent by motorized fans through fresh air diffusers (see [Figure 1](#)). Univents were found turned off in classrooms throughout the school. Obstructions to airflow, such as papers and books stored on univents and bookcases, carts and desks in front of univent returns were seen in a number of classrooms (see Picture 2). Some univents also contained accumulated dirt/debris. These univents should be cleaned before operating to prevent aerosolization of this material.

Obstructions to Univent Airflow

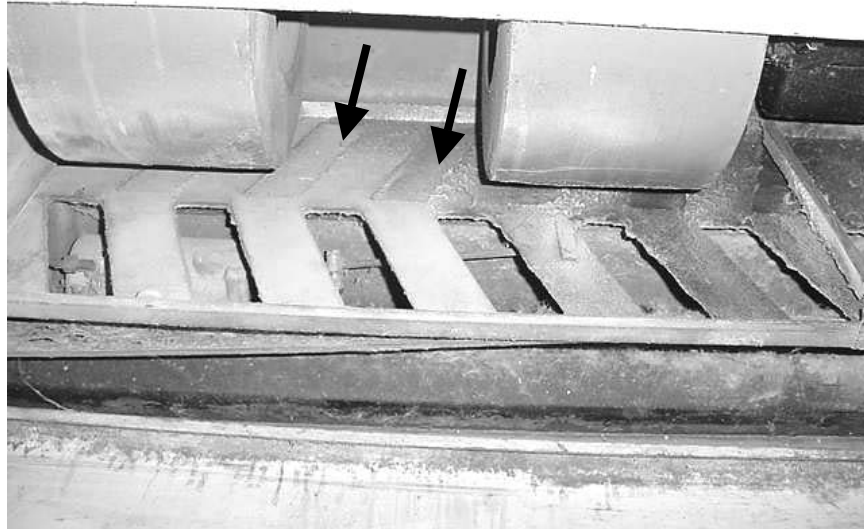
Picture 3

This recommendation should take into account the practicality of restoring the existing univents. An examination of the interior of univents revealed significant alterations to the louver mechanisms. These alterations either reduce or eliminate the ability of univents to draw fresh outdoor air. In addition, the manufacturer of the univents [Schemenn (see Picture 7)] appears to have ceased operations. No internet web site could be identified for this company, which indicates there may not be a source to obtain replacement parts to restore univent fresh air intakes to their original function. Without replacement parts to restore the univents, balancing of the HVAC system may not be possible.

**“Pan Louver” Airflow Control Inside Univents, Note Closed Louver Slots in Rear
Limiting Fresh Air Intake**

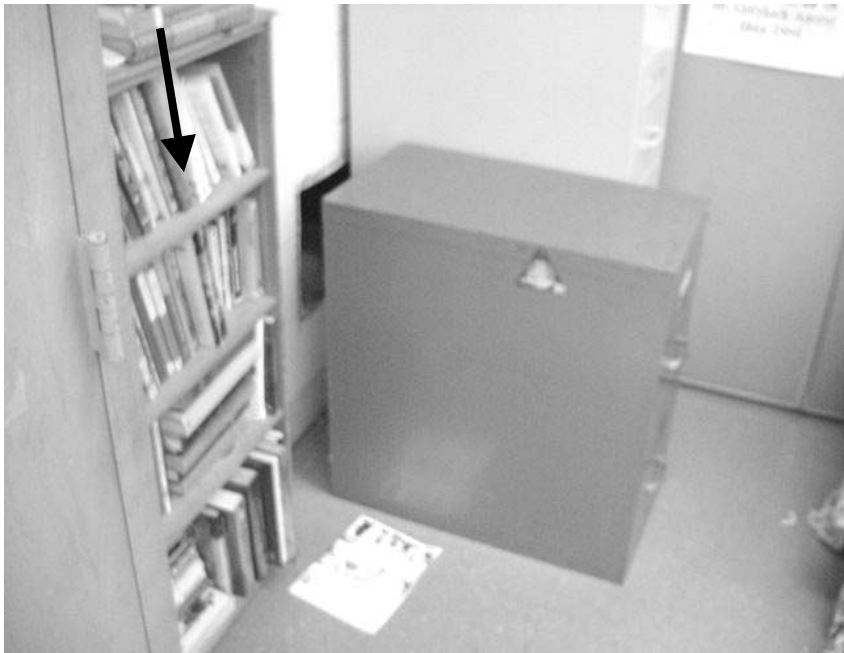
Picture 4

Mechanical exhaust ventilation is supplied by wall-mounted vents powered by rooftop motors. Exhaust vents were found off in a number of rooms. Some exhaust vents were obstructed by filing cabinets (see Picture 4) and other equipment. In several classrooms, the exhaust vent was located behind a closed room divider (see Picture 5) or hallway door. Exhaust vents must remain clear of obstruction in order to remove stale air and pollutants from classrooms.

Obstructed Exhaust Vent

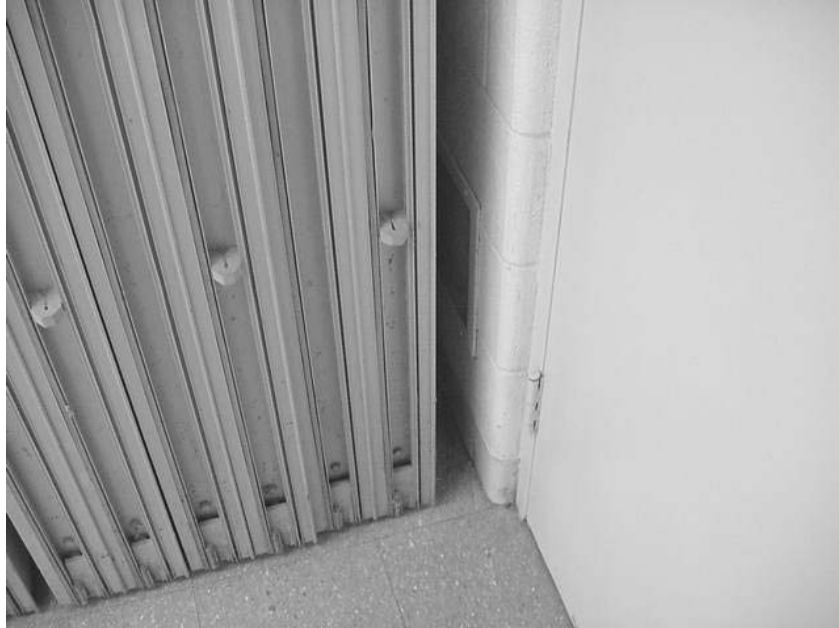
Picture 5

Exhaust Vent Blocked by Room Divider

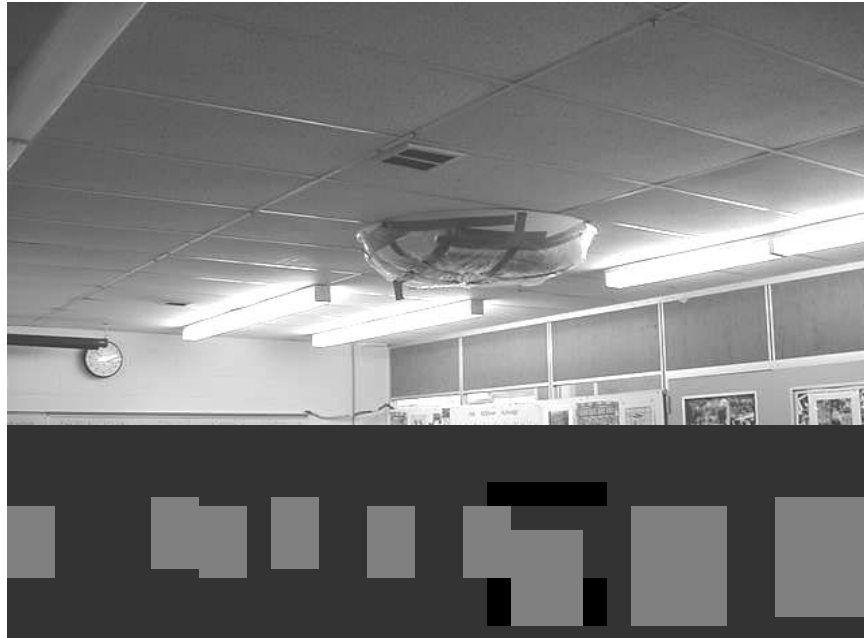
Picture 6

Oversized Fresh Air Diffuser in Classroom Connected to Library HVAC System

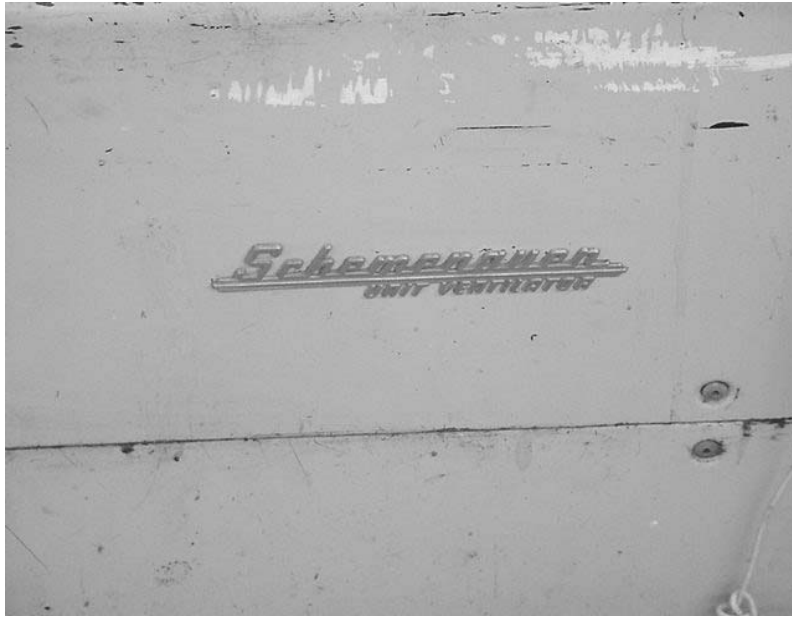
Picture 7

Univent Manufacturer Label

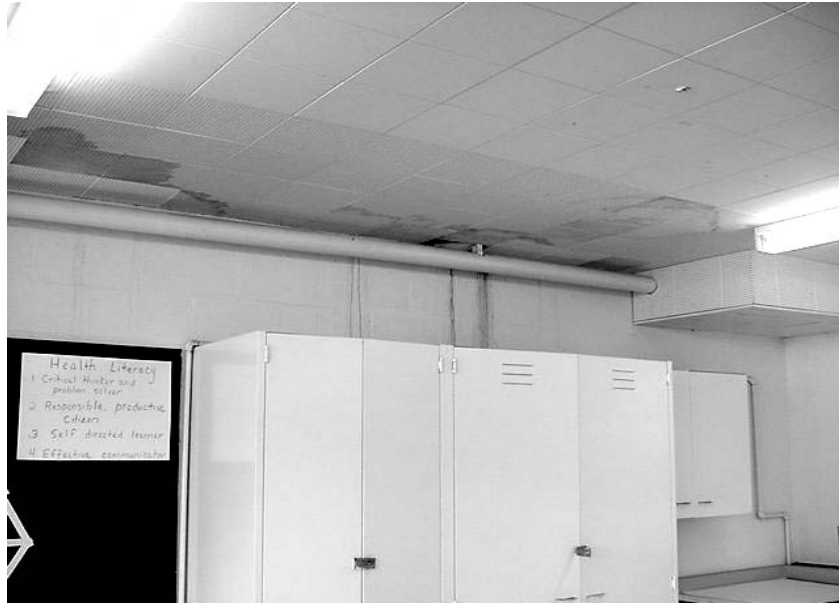
Picture 8

The school has a ceiling tile system that is glued directly to the ceiling in some classrooms. A number of hallways and classrooms have ceiling tiles that appear to be water-damaged by either water penetration through window frames or by leaks around ductwork that penetrate the roof (see Picture 8). Replacement of these ceiling tiles is difficult, since their removal appears to necessitate the destruction of the tile, which can result in the aerosolization of particulates. Water-damaged ceiling tiles may provide a medium for microbial growth and should be replaced after a water leak is discovered.

Water Damaged Ceiling Tiles Glued to Ceiling, also Note Water Damage on Walls

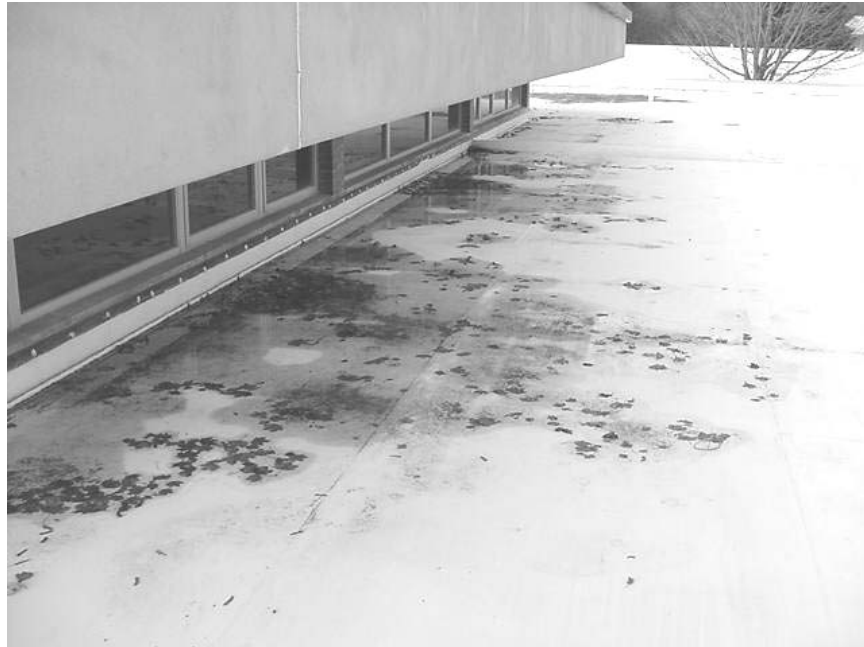
Picture 9

Various forms of debris [leaves (see Picture 9)] were noted in direct contact with the rubber membrane roof. In one instance, plants had taken root in the debris and were growing on the roof membrane. Debris can hold water in contact with the roof, which may cause damage resulting in leaks from freezing and thawing during cold weather.

Debris on Roof

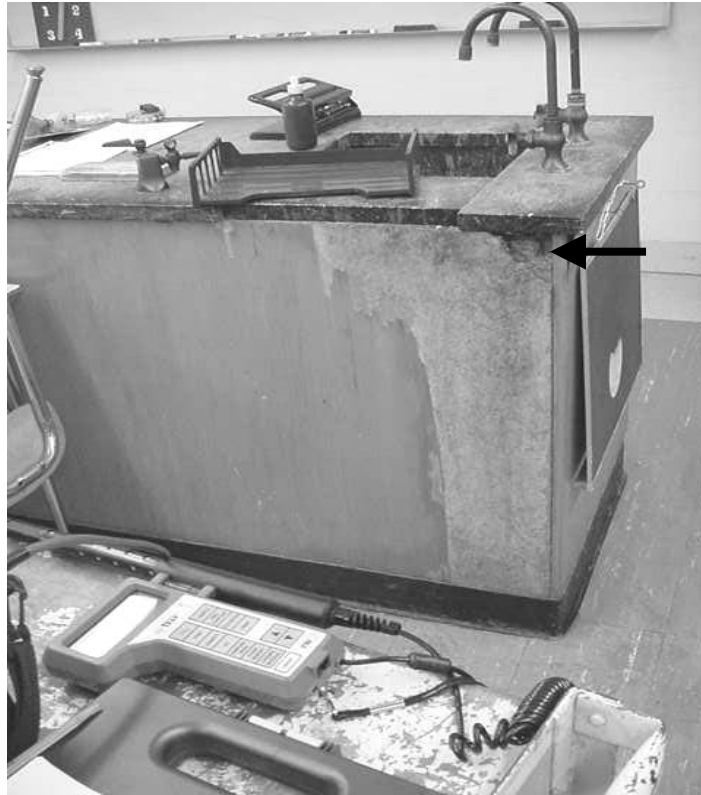
Picture 10

A number of several classrooms have cabinets that are water damaged from spaces between sink countertops and splashboards (see Picture 10). Water penetration and chronic wetting of wood can cause these materials to swell and serve as a growth medium for mold.

**Water Damaged Sink Cabinet, Note Blackening of Particleboard,
Which May Indicate Mold Growth (See Arrow)**

10. Remove and replace water damaged sink cabinet materials. Seal areas around sinks to prevent water-damage to the interior of cabinets. Disinfect areas of microbial growth with an appropriate antimicrobial as needed.

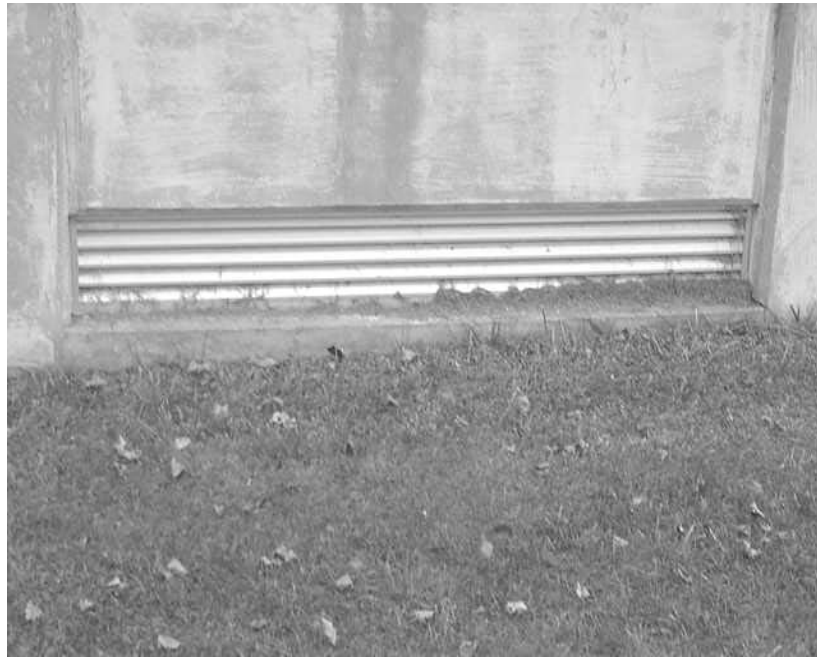
Picture 11

A significant amount of moistened outdoor debris (cut grass) was found between louvers of univent fresh air intakes (see Picture 11). This material can be drawn into the air stream of univents and provide a source of allergenic material as well as a mold growth medium. Shrubbery in close proximity to univent fresh air intakes (see Picture 12) or in direct contact with the exterior wall brick was noted in several areas around the building, including pine trees in a courtyard located between the library and rooms 55 through 59. Shrubbery growing directly against the building can serve as a possible source of water impingement on the exterior curtain wall. In addition, the growth of roots against exterior walls can bring moisture in contact with wall brick and eventually lead to cracks and/or fissures in the slab. Over time, this process can undermine the integrity of the building envelope and provide a means of water entry into the building through capillary action through foundation concrete and masonry (Lstiburek, J. & Brennan, T.; 2001).

Debris over Univent Fresh Air Intake

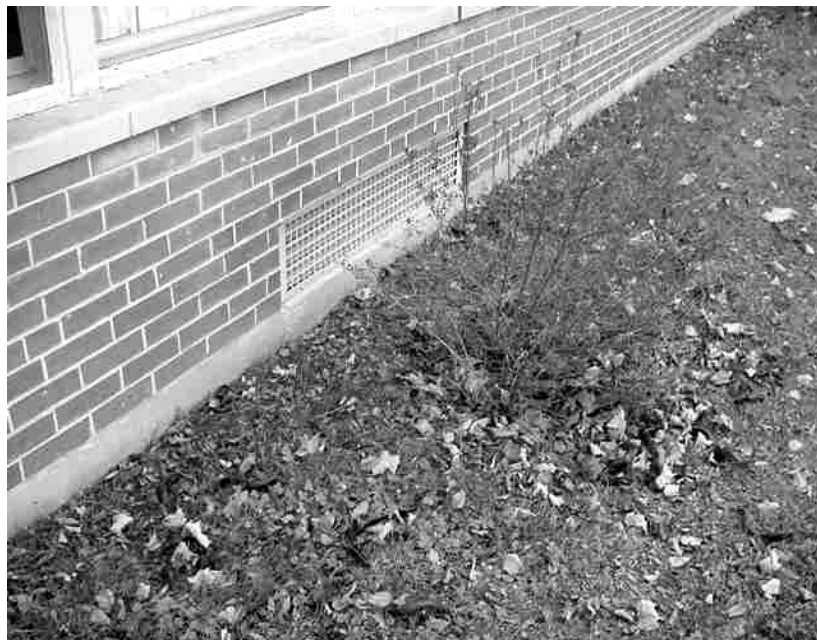
Picture 12

Shrubby In Front Of Univent Fresh Air Intake

12. Remove trees and/or plant growing against the exterior wall/foundation of the building to prevent water penetration. Consider relocating/removal of pine trees in courtyard.

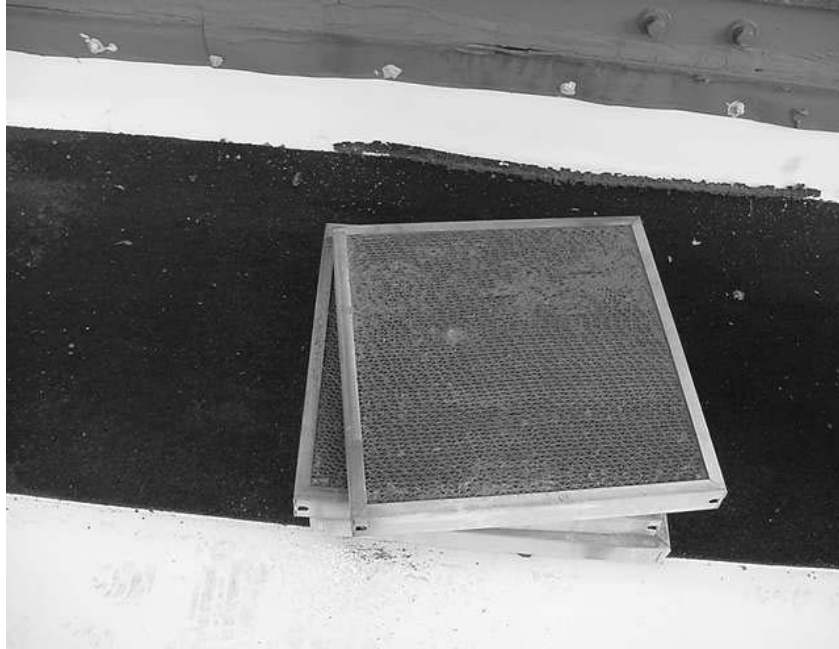
Picture 13

Several other conditions were noted during the assessment, which can affect indoor air quality. Air filters in univents and rooftop AHUs consisted of ill-fitting metal screens that provide minimal filtration of respirable dust (see Picture 13). Univent filters are designed to strain particulates from airflow. In order to decrease aerosolized particulates, disposable filters with an increased dust spot efficiency can be installed. The dust spot efficiency is the ability of a filter to remove particulates of a certain diameter from air passing through the filter. Filters that have been determined by ASHRAE to meet its standard for a dust spot efficiency of a minimum of 40 percent would be sufficient to reduce airborne particulates (Thornburg, D., 2000; MEHRC, 1997; ASHRAE, 1992). Note that increased filtration can reduce airflow produced by increased

Wire Mesh Filter for Rooftop AHU

5. Examine the feasibility of increasing HVAC filter efficiency. Ensure that installed filters are of a proper size and installed in a manner to eliminate particle bypass of the filter. Note that prior to any increase of filtration, each unit should be evaluated by a ventilation engineer as to whether they can maintain function with more efficient filters. Please note that this recommendation is contingent on examination and repair of univents system made under long-term recommendations made in this report.

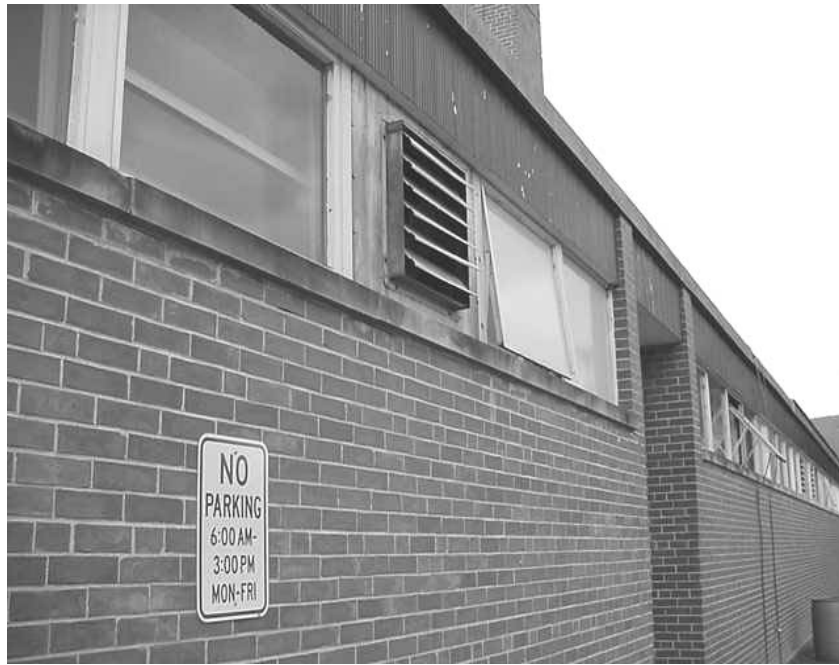
Picture 14

An exhaust vent fan was found with its hinged louvers frozen open (see Picture 14). These exhaust vent louvers are designed to close when the fan is deactivated. With the louvers open, an uncontrolled amount of outdoor air can enter the building, making temperature control difficult in this area. This vent can also lead to moisture penetration and water damage to building fixtures. This vent also can serve as a means of access for animals and insects to gain entry into the building. All of these examples can have an adverse effect on indoor air quality.

Exhaust Vent with Louver Frozen in Open Position

3. Repair frozen exhaust vent louvers in Picture 14.
4. To maximize air exchange, the BEHA recommends that both supply and exhaust ventilation operate continuously during periods of school occupancy independent of classroom thermostat control. Please note that this recommendation is contingent on examination and repair of univents system made under long-term recommendations made in this report.

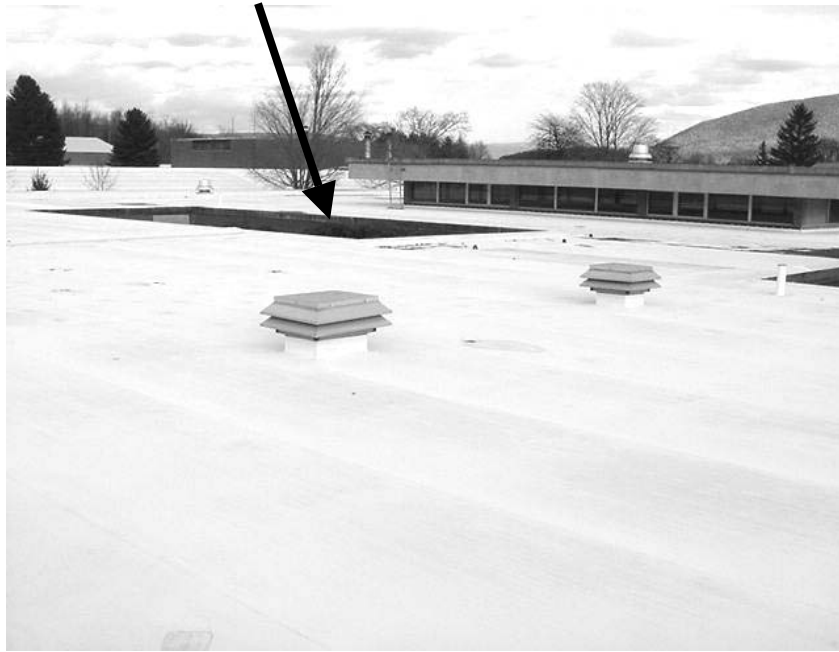
Picture 15

Rooftop Fresh Air Intakes for Interior Rooms, Note Courtyard (See Arrow)

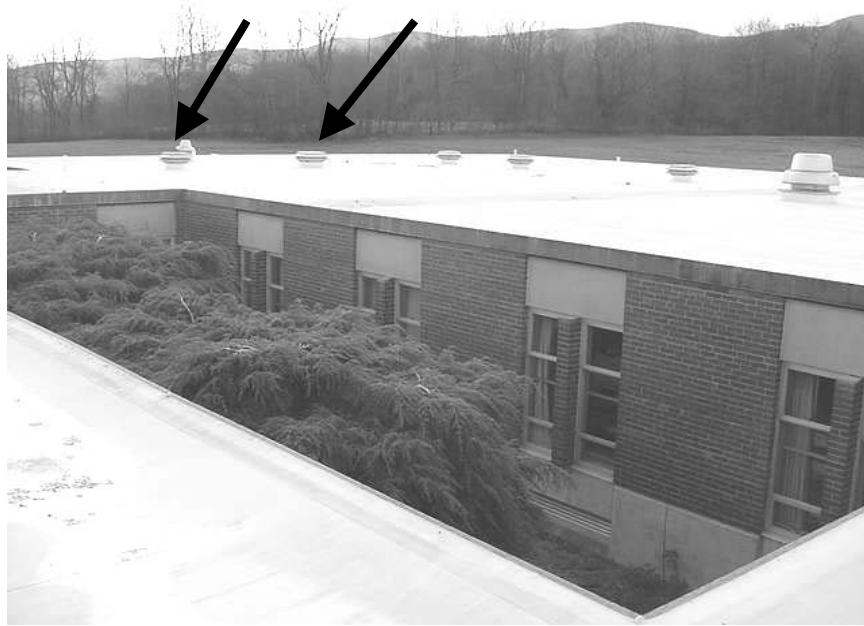
Picture 16

Possible sources of organic dust (e.g., pollen) were also evaluated. A stand of several pine trees, which could be a source of pollen, grow within the courtyard of the building. The tops of these trees are above the roofline. The fresh air intakes for rooms of interest are located on the roof (see Picture 15). The courtyard is thirty feet to the east of this fresh air intake (see Picture 16). Under the right wind conditions, it is possible that pollen from these trees could pass over the univent fresh air intakes. However, no accumulation or discoloration of dust associated with pollen was noted within the univent fresh air intake or univent cabinet. It is also important to note that draw of fresh air through the room's univent is minimal at best, as outlined in the ventilation section of this report.

Courtyard with Stand of Several Pine Trees, Note Location of Interior Room Fresh Air Intakes (See Arrows)
